Asphalt Shingle History:

Typical Shingle Components

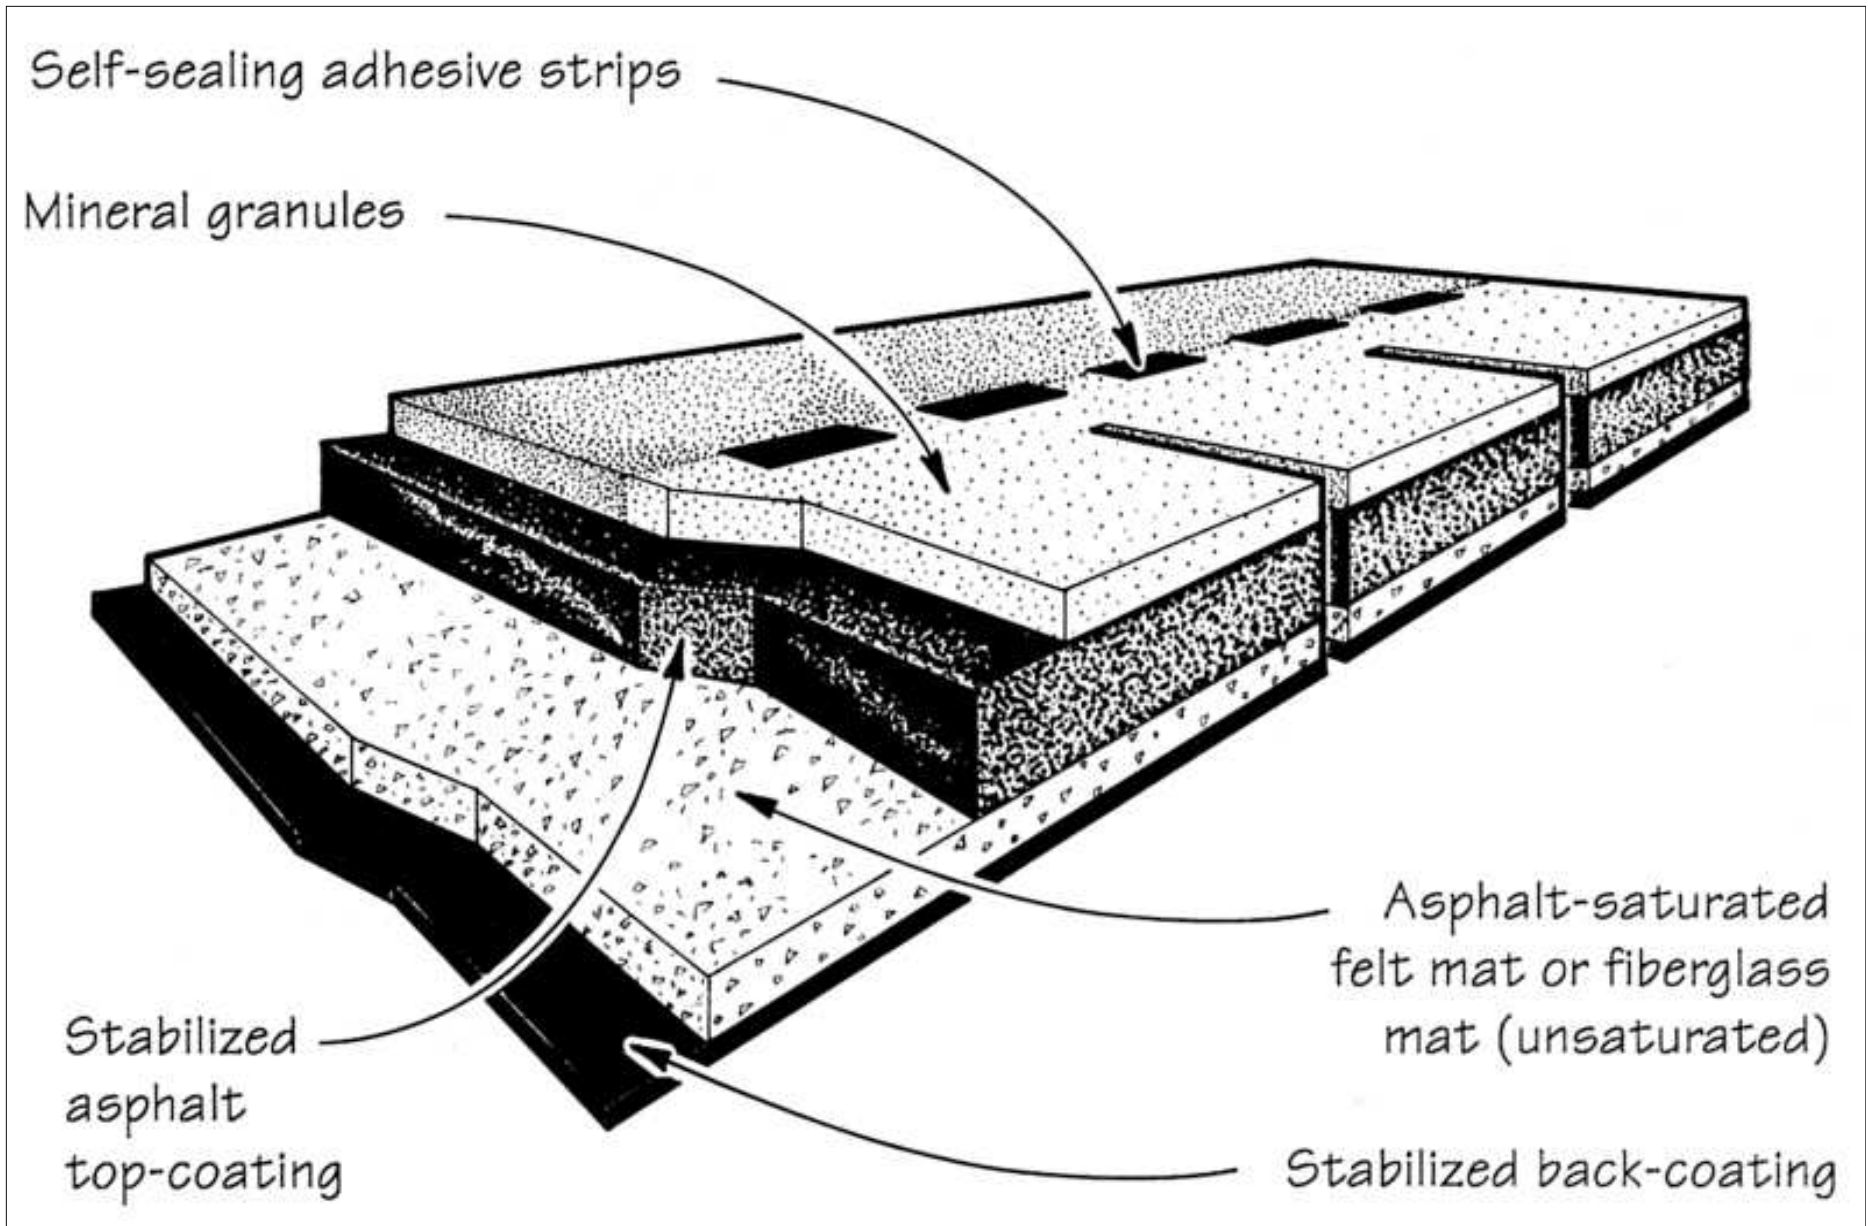
All asphalt shingles are built around a mat of either organic felt or fiberglass. The organic mats are thicker and are saturated with soft, pliable asphalt. Both types of shingles have a top layer of harder, stabilized asphalt topped with colored stone to protect against UV light. On the bottom, all shingles have a thin coating of asphalt coated with talc, sand, or mica to keep the shingles from sticking together in the package.

Basic Components: (see page # 2 for a visual)

All asphalt shingles consist of an inner reinforced fiber mat coated with asphalt. The fiber mat, which gives the shingle most of its strength, is made either from an *organic cellulose material* (derived from wood or recycled paper) or from newer technology *fiberglass material*. On top of the inner reinforcing mat is a coating of asphalt (*thicker for organic mats, thinner for fiberglass mats*), followed by a top surfacing of small granules of rock which are colored with a ceramic coating, to protect/reflect damaging sunlight. On the back is a stabilizing back-surface asphalt layer (organic shingles) and finely ground mineral dust used to retard adhesion while in storage. On the back a stripe of adhesive helps to resistant shingle movement from wind.

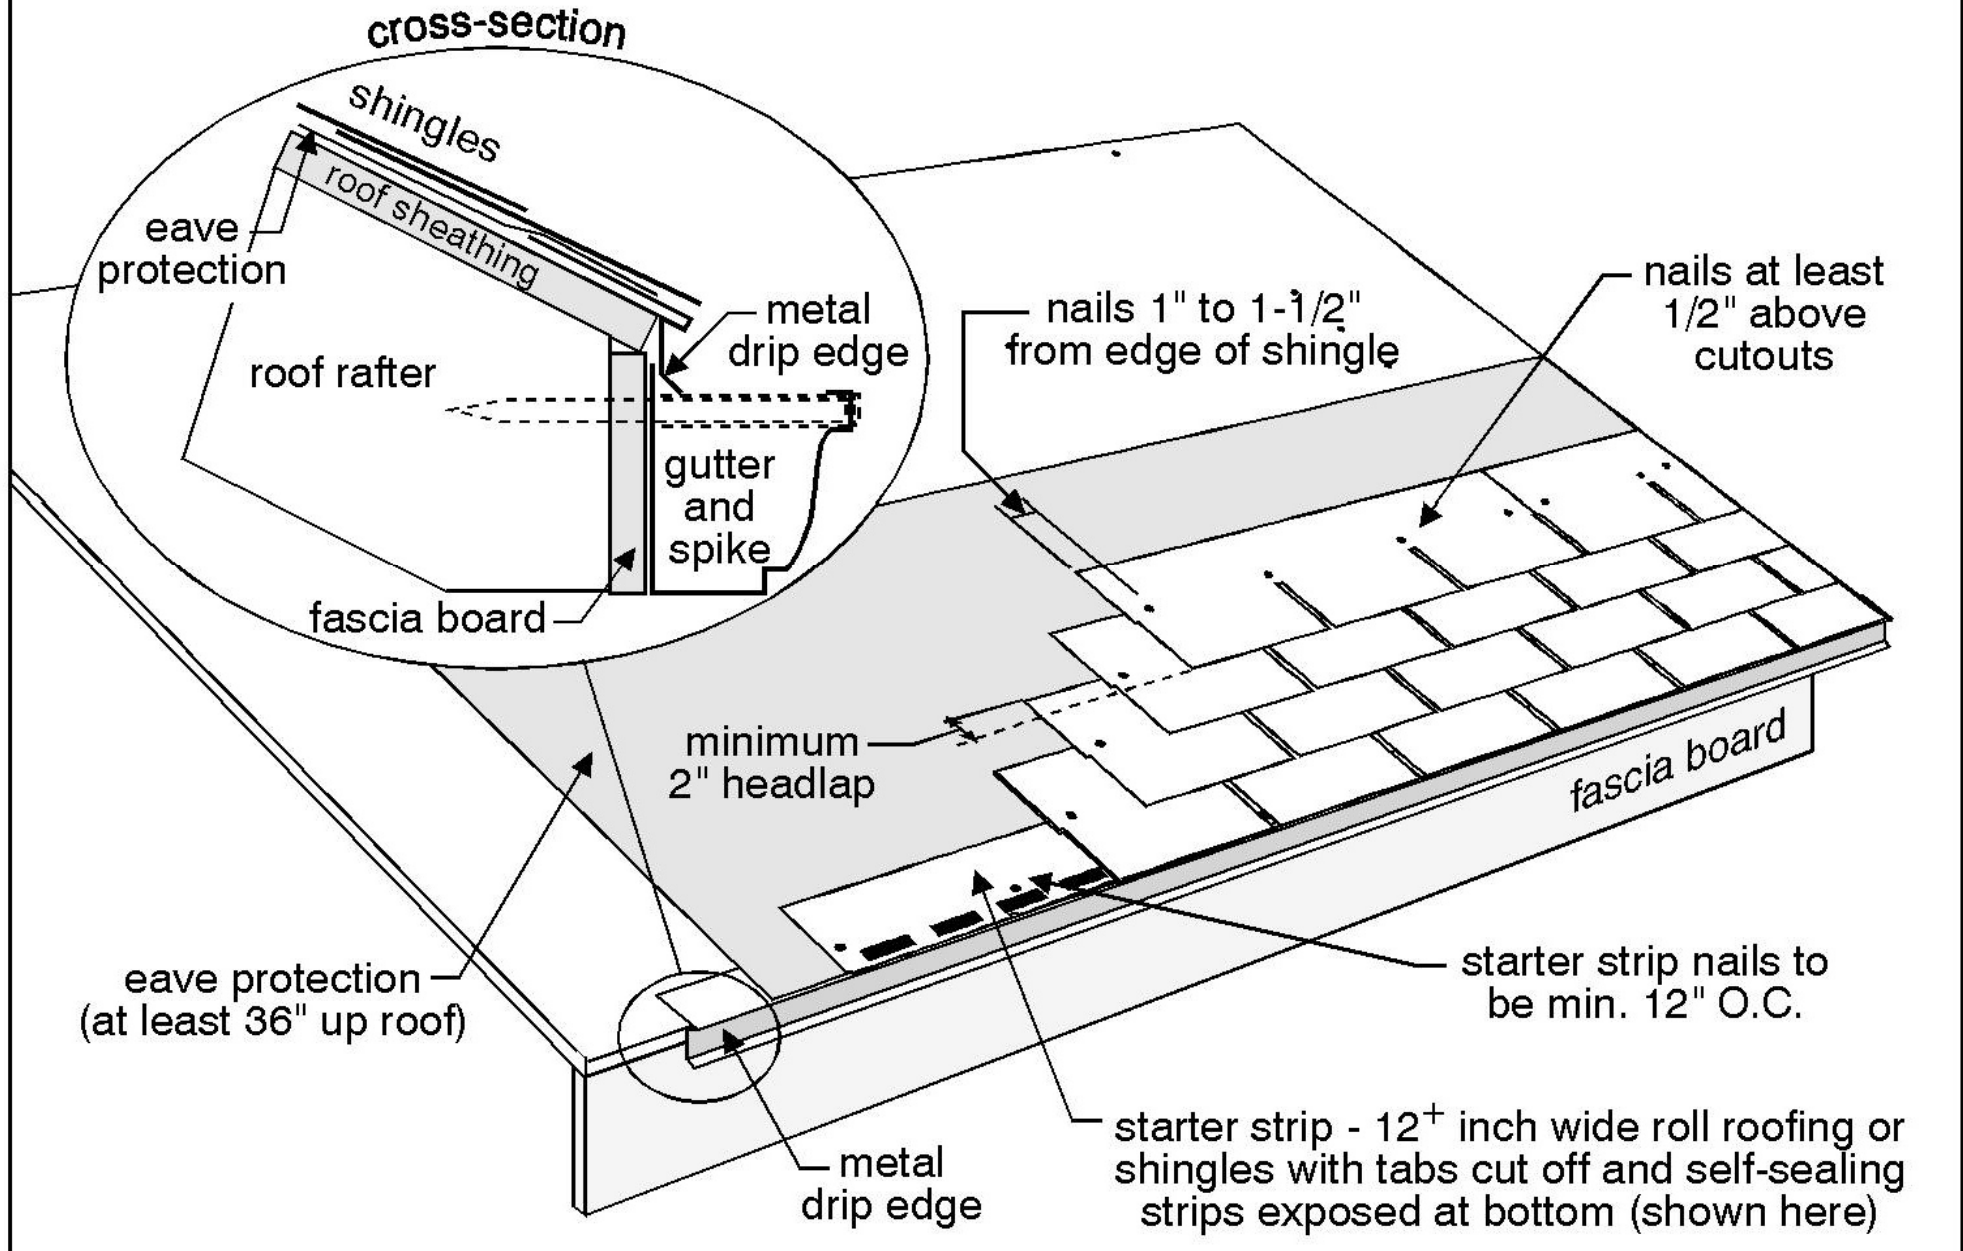
Typical asphalt shingle application - showing metal drip edge

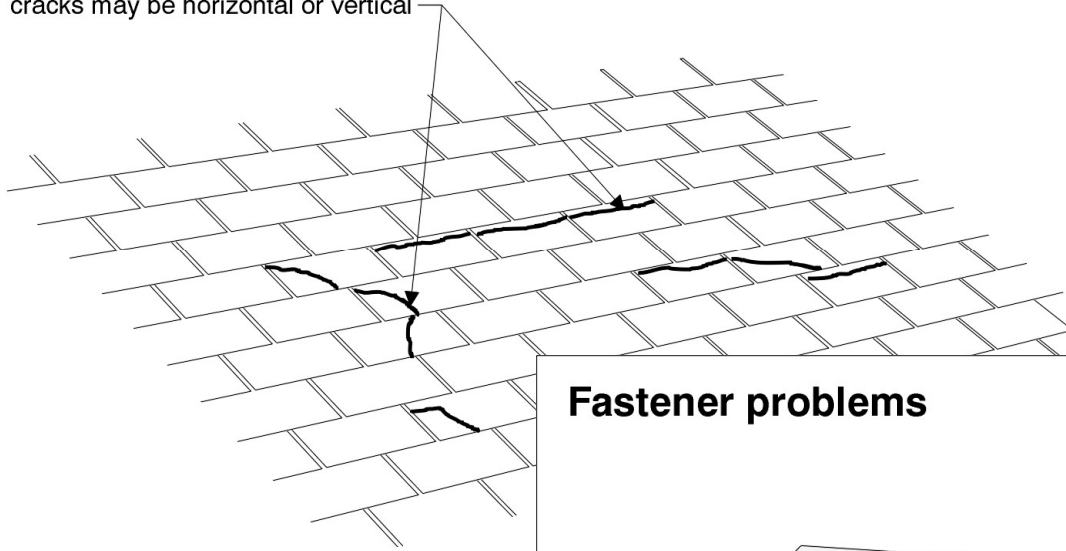
Premature failure of asphalt shingles

premature cracking of shingles can occur even in newer asphalt shingle applications
cracks may be horizontal or vertical

- Incorporate one thinner layer of asphalt.
- Bonded together with a phenolic adhesive which is affected less by moisture.
- A less flexible more brittle type of shingle. More susceptible to shingle tear off in windy conditions and severe cracking (through the entire shingle) from thermal expansion/contraction of shingle and roof decking structure and sheathing surfaces.
- A lighter, easier to install, easier to ship shingle which is often less expensive compared to organic shingles.
- Normal aging includes a dullness to shingle surfaces, missing granules, severe brittleness & cracking. Cupping/curling are much less common compared to organic shingles.

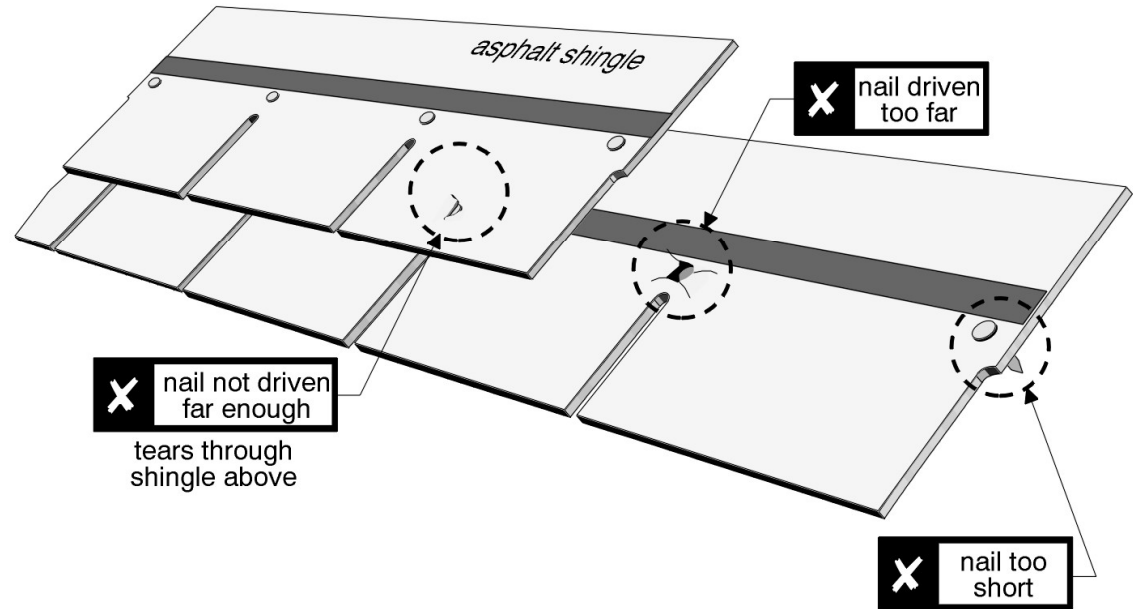
Fastener problems
